NASA Technical Memorandum 104810

Space Shuttle Orbiter Corrosion History, 1981-1993

A Review and Analysis of Issues Involving Structures and Subsystems

**A report of the
Orbiter Corrosion Control Review Board**

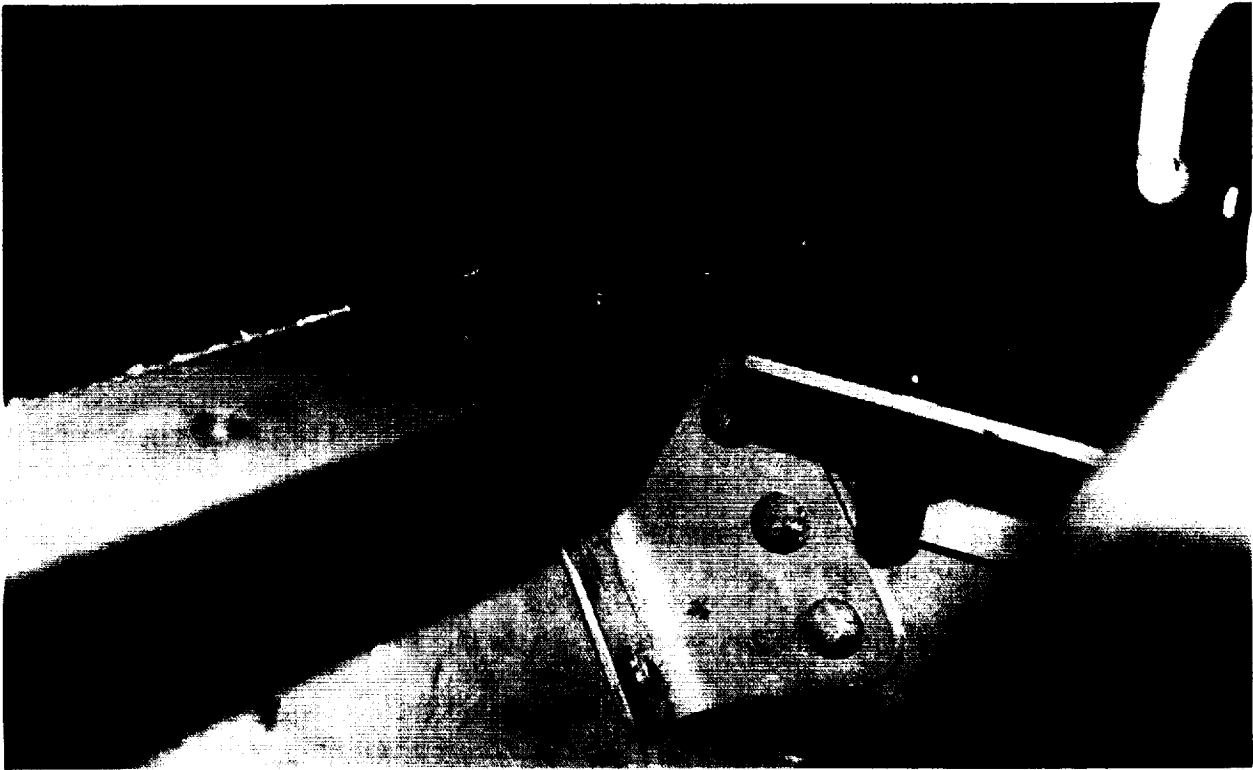
- d. Body Flap Cove. Corrosion was recently discovered in the body flap cove of OV-103, shown in figure 8. Two areas of corrosion were noted: (1) rivets in the cove area and (2) at the actuator fitting to airframe faying surfaces. Corrosion of the rivets has been attributed to a galvanic couple between the aluminum rivets and titanium actuator fittings. Structural analysis indicated that the need for the rivets was minimal. The rivets are not replaced until 30% of the exposed head is missing. The actuator fitting corrosion was pitting. These areas were all cleaned and re-Koroponed. Mold impressions revealed defect dimensions 0.623 inches long, 0.195 inches wide and 0.023 inches deep; the fitting in this area is 0.080 inches thick. These items are currently under review by the CCRB.

Figure 8. Corrosion found on the body flap cove structure from OV-103.
